**VIBRATION LABORATORY**<http://www.kdi.tw><http://www.vibration.com.tw>E-mail: [service@kdi.tw](mailto:service@kdi.tw)**TESTING / INSPECTION REPORT**

REPORT NO : VT-170428-5

SPECIMEN : TEK3-IMX6G series No1.  
TEK3-IMX6G series No2.

TEST / INSPECTION ITEMS : Vibration Test

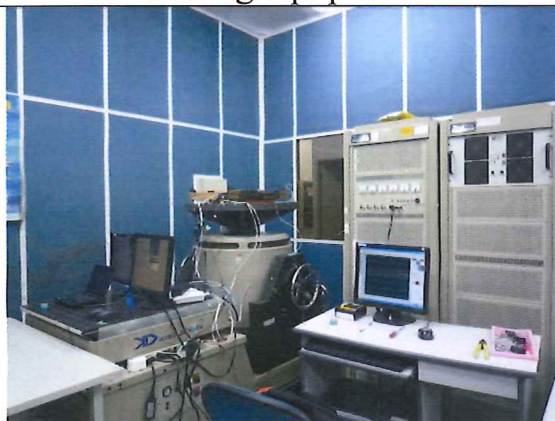
Testing equipment

| 1. Vibration Tester | : KING DESIGN KD-9363EM-1000F2K-50N120,<br>S/N : GUG02102091 |
| 2. Controller | : DACTRON LASER USB, S/N : 12448370 |
| 3. Control Accelerometer | : WILCOXON RESEARCH WR-784A, S/N : 23116 |
