**VIBRATION LABORATORY**<http://www.kdi.tw><http://www.vibration.com.tw>E-mail: [service@kdi.tw](mailto:service@kdi.tw)**TESTING / INSPECTION REPORT**

REPORT NO : VT-170508-1

SPECIMEN : TEP0500-IMX6 series

TEST / INSPECTION ITEMS : Vibration Test

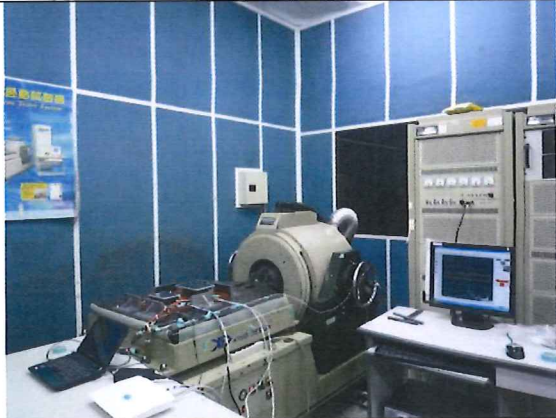
Vibration testing photos	
Testing equipment	Z axis

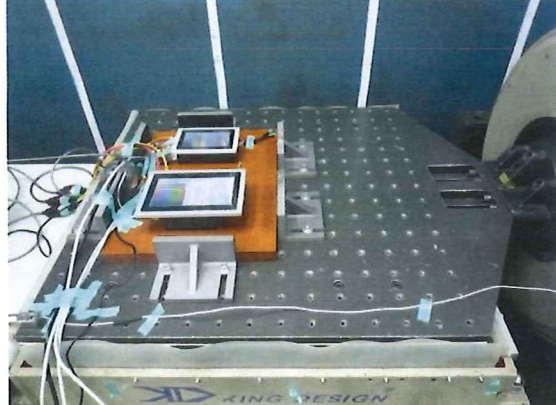
X axis	Y axis
