VIBRATION LABORATORY<http://www.kdi.tw><http://www.vibration.com.tw>E-mail: service@kdi.tw**TESTING / INSPECTION REPORT**

REPORT NO : VT-170508-2

SPECIMEN : TEP0700-IMX6 series

TEST / INSPECTION ITEMS : Vibration Test

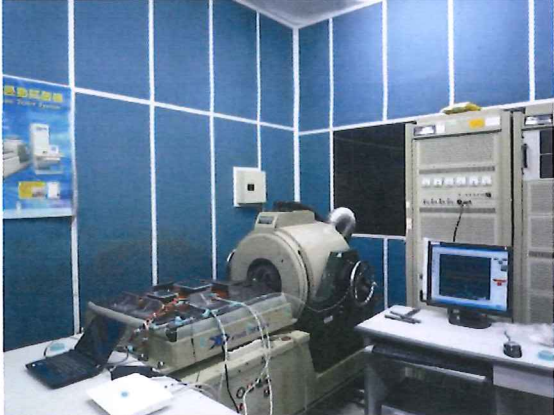
Vibration testing photos	
Testing equipment	Z axis

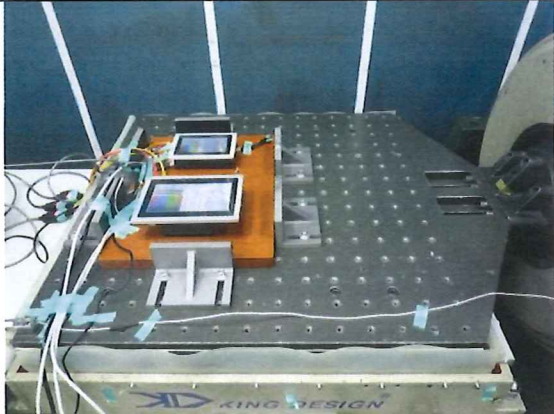
X axis	Y axis

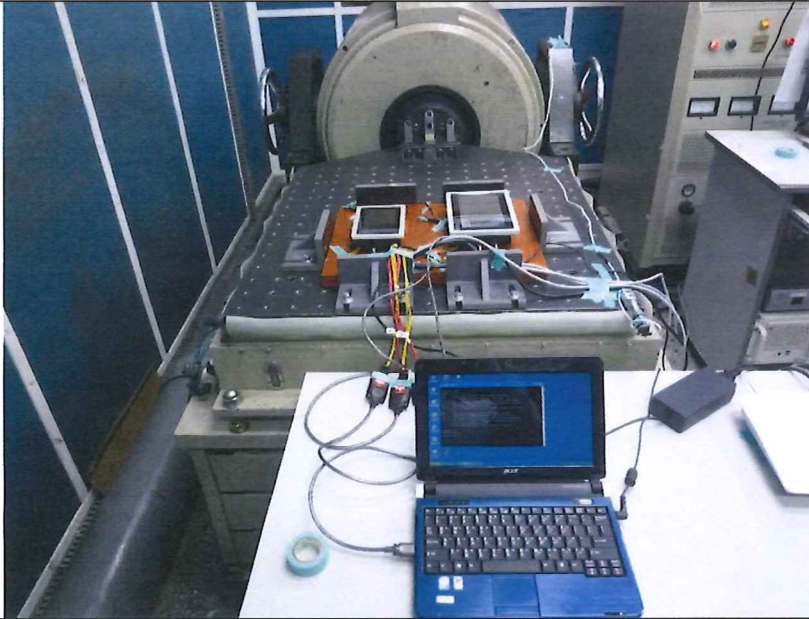
E-mail: service@kdi.tw
Testing photos
After test-1

Describe	PASS	FAIL	Non-Judgment
Function judgment	√	---	---
Appearance check	√	---	---
